TRW Automotive Commercial Steering Systems

Service Procedure COL-195

GEN II Steering Column Diagnostic Guide

April 2016

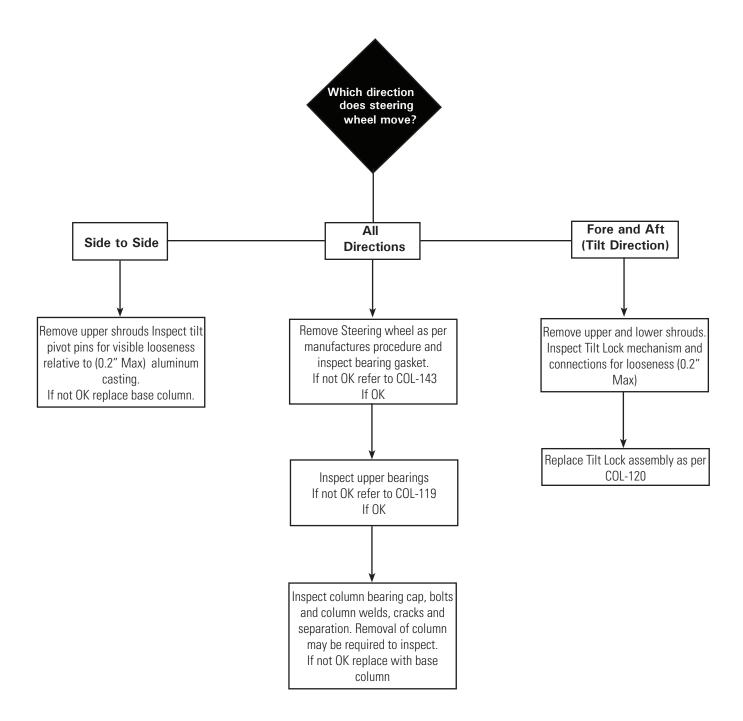
COLUMN LOOSE

Tilt and Telescope lock and unlock function

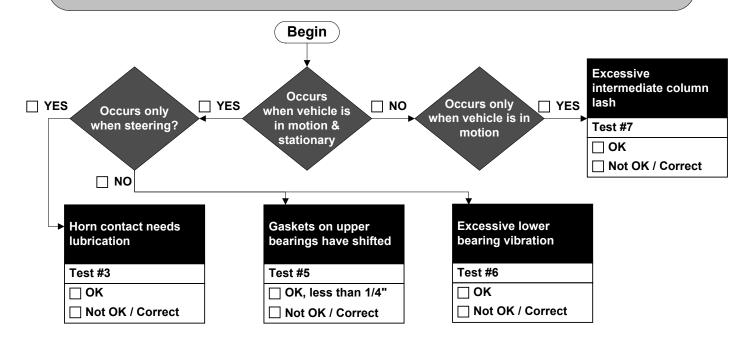
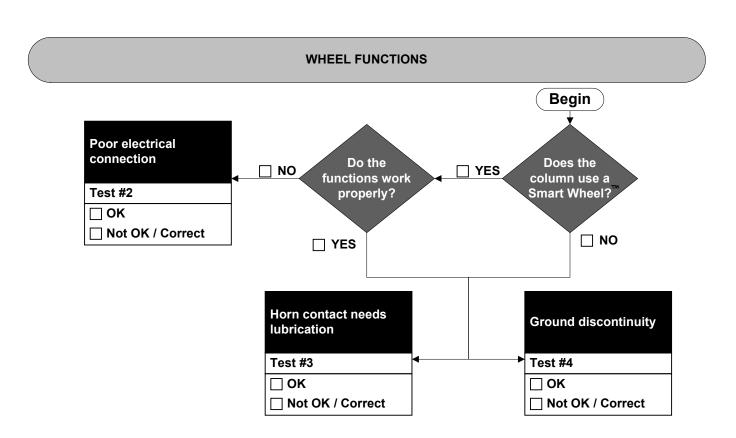
COLUMN NOISE & VIBRATION

- Test #3 Symptoms include rubbing or squeaking noise that occurs when the steering wheel is moved. If column does not include a clockspring, remove steering wheel and add dielectric grease to the horn contact as specified in TRW Service Bulletin COL-147. If noise continues, check steering wheel and shroud. Refer to Manufacturers Service Manual.

- Test #4 Symptoms include intermittent or non-functioning city horn in standard wheel. Check for ground continuity between shaft where steering wheel mounts and the aluminum die cast housing on the top of the column. If discontinuity is found refer to TRW Service Bulletin COL-114. Check dielectric grease on horn contact as Test #3. Refer to Manufacturers Service Manual.

- Test #5 Symptoms include excessive looseness in steering wheel. Apply light force to steering wheel, move side to side (toward driver and passenger door). Relative movement between steering wheel and shroud should be less than 1/4". Check upper bearing gaskets. Gaskets should cover bearing. If gaskets are not in correct location refer to TRW Service Bulletin COL-143. Refer to Manufacturers Service Manual.

- Test #6 Symptoms include noise or vibration that can be felt moving or when vehicle is stationary. Problem is engine speed related. Apply side load to intermediate column (I-Shaft). If problem disappears for fixed columns, refer to TRW Service Bulletin COL-145. Refer to Manufacturers Service Manual.

- Test #7 Symptoms include driver complaining of feeling "pins and needles" in hands. Problem associated with bumps or holes in the road. Check intermediate column (I-Shaft) for torsional lash in u-joints or slip section. Replace intermediate column if necessary. Refer to Manufacturers Service Manual.

- Test #1 Repair or replace shrouding. Refer to Manufacturers Service Manual.
- Test #2 Symptoms include Smart Wheel functions not working properly or are intermittent. If column includes a clockspring, check the Smart Wheel & controller. Check clockspring. Replace parts if necessary. Refer to Manufacturers Service Manual.
